MISSION REPORT / RAPPORT DE MISSION

**Vat Phou and Associated Ancient Settlements within the Champasak Cultural Landscape (N481)/Vat Phou et les anciens établissements associés du paysage culturel de Champassak (République démocratique populaire lao) (N 481)
15-21 February 2012/15-21 février 2012**

Report on the Joint World Heritage Centre/ICOMOS/ICCROM Reactive Monitoring Mission to Vat Phou and Associated Ancient Settlements within the Champasak Cultural Landscape (Lao People's Democratic republic)

15-21 February 2012

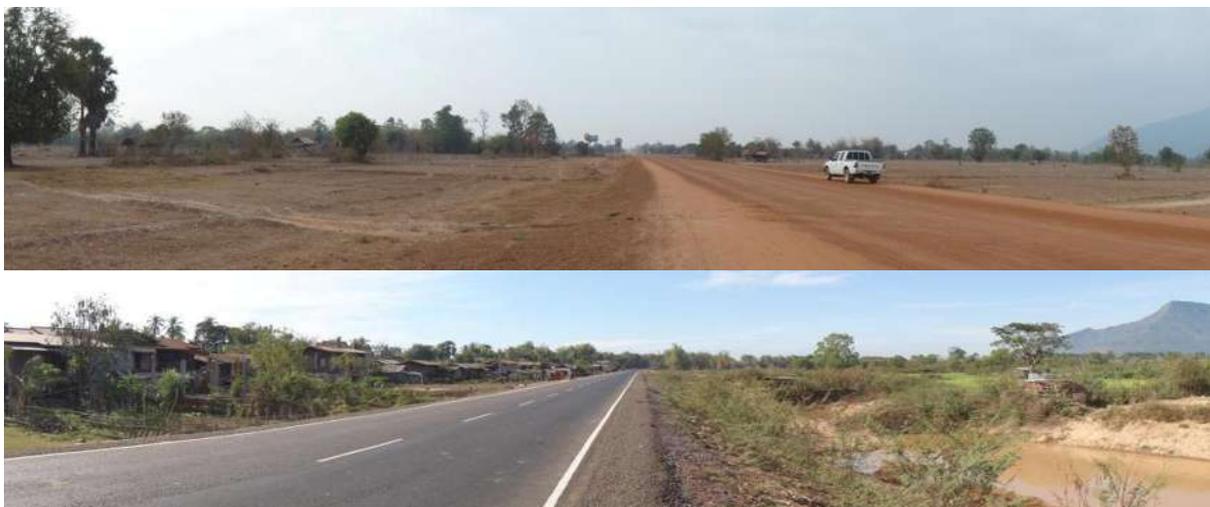
14A under construction (above) and as constructed (below)

Consequently, on 22 November 2010, per a letter from the World Heritage Centre, the State Party was asked to suspend all further road construction on Route 14A, pending a thorough Cultural Heritage Impact Assessment. The concerns included the possible impact of the road on important archaeological resources (both during and after construction) and the visual

impact of the completed road (and associated bridges) on the cultural landscape. There was also concern that the road, designated a regional road, could well develop into a national four-lane highway. This concern was not specifically expressed in the aforementioned letter from the World Heritage Centre, but later shared by those knowledgeable about the project. At the time of the Reactive Monitoring Mission, all work had been stopped on KM 29 + 050 to KM 34 + 261; a section of Route 14A that includes three partially constructed bridges. The remaining part of Route 14A has been largely finished
