MISSION REPORT / RAPPORT DE MISSION

**Vat Phou and Associated Ancient Settlements within the Champasak Cultural Landscape (N481)/Vat Phou et les anciens établissements associés du paysage culturel de Champassak (République démocratique populaire lao) (N 481)
15-21 February 2012/15-21 février 2012**

Report on the Joint World Heritage Centre/ICOMOS/ICCROM Reactive Monitoring Mission to Vat Phou and Associated Ancient Settlements within the Champasak Cultural Landscape (Lao People's Democratic republic)

15-21 February 2012

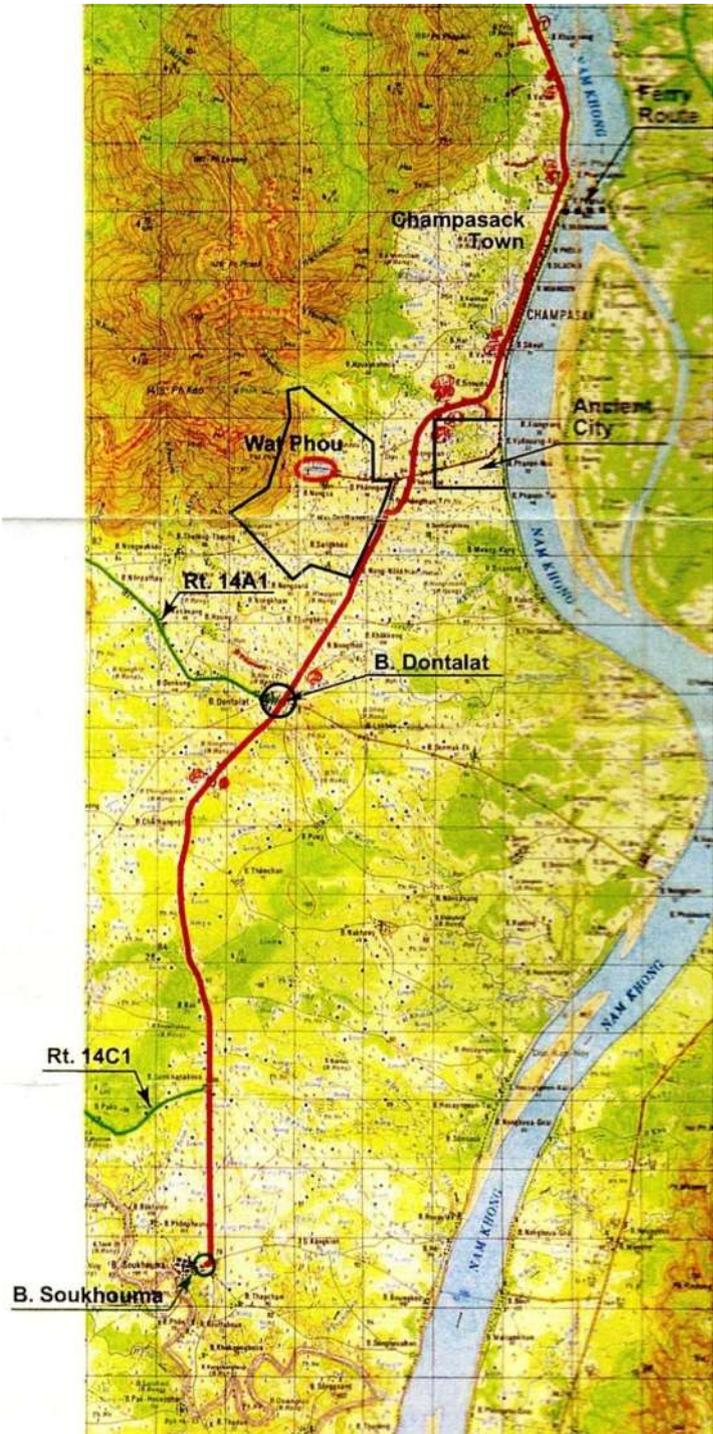
Map showing Route 14A

The mission notes that Route 14A has direct impact on Zone 1 [Champasak Heritage and Cultural Landscape Protection Zone] and Zone 3 [Archaeological Research Zone] – and indirect impact on Zone 2 [Sacred Zone] and Zone 4 [Monumental Management Zone]. (See Annexe 6 for map showing zone boundaries within the property).
